Advisory Notice for Titan T-51 Mustang Aircraft

March 4, 2009

Service recommended before any further flights

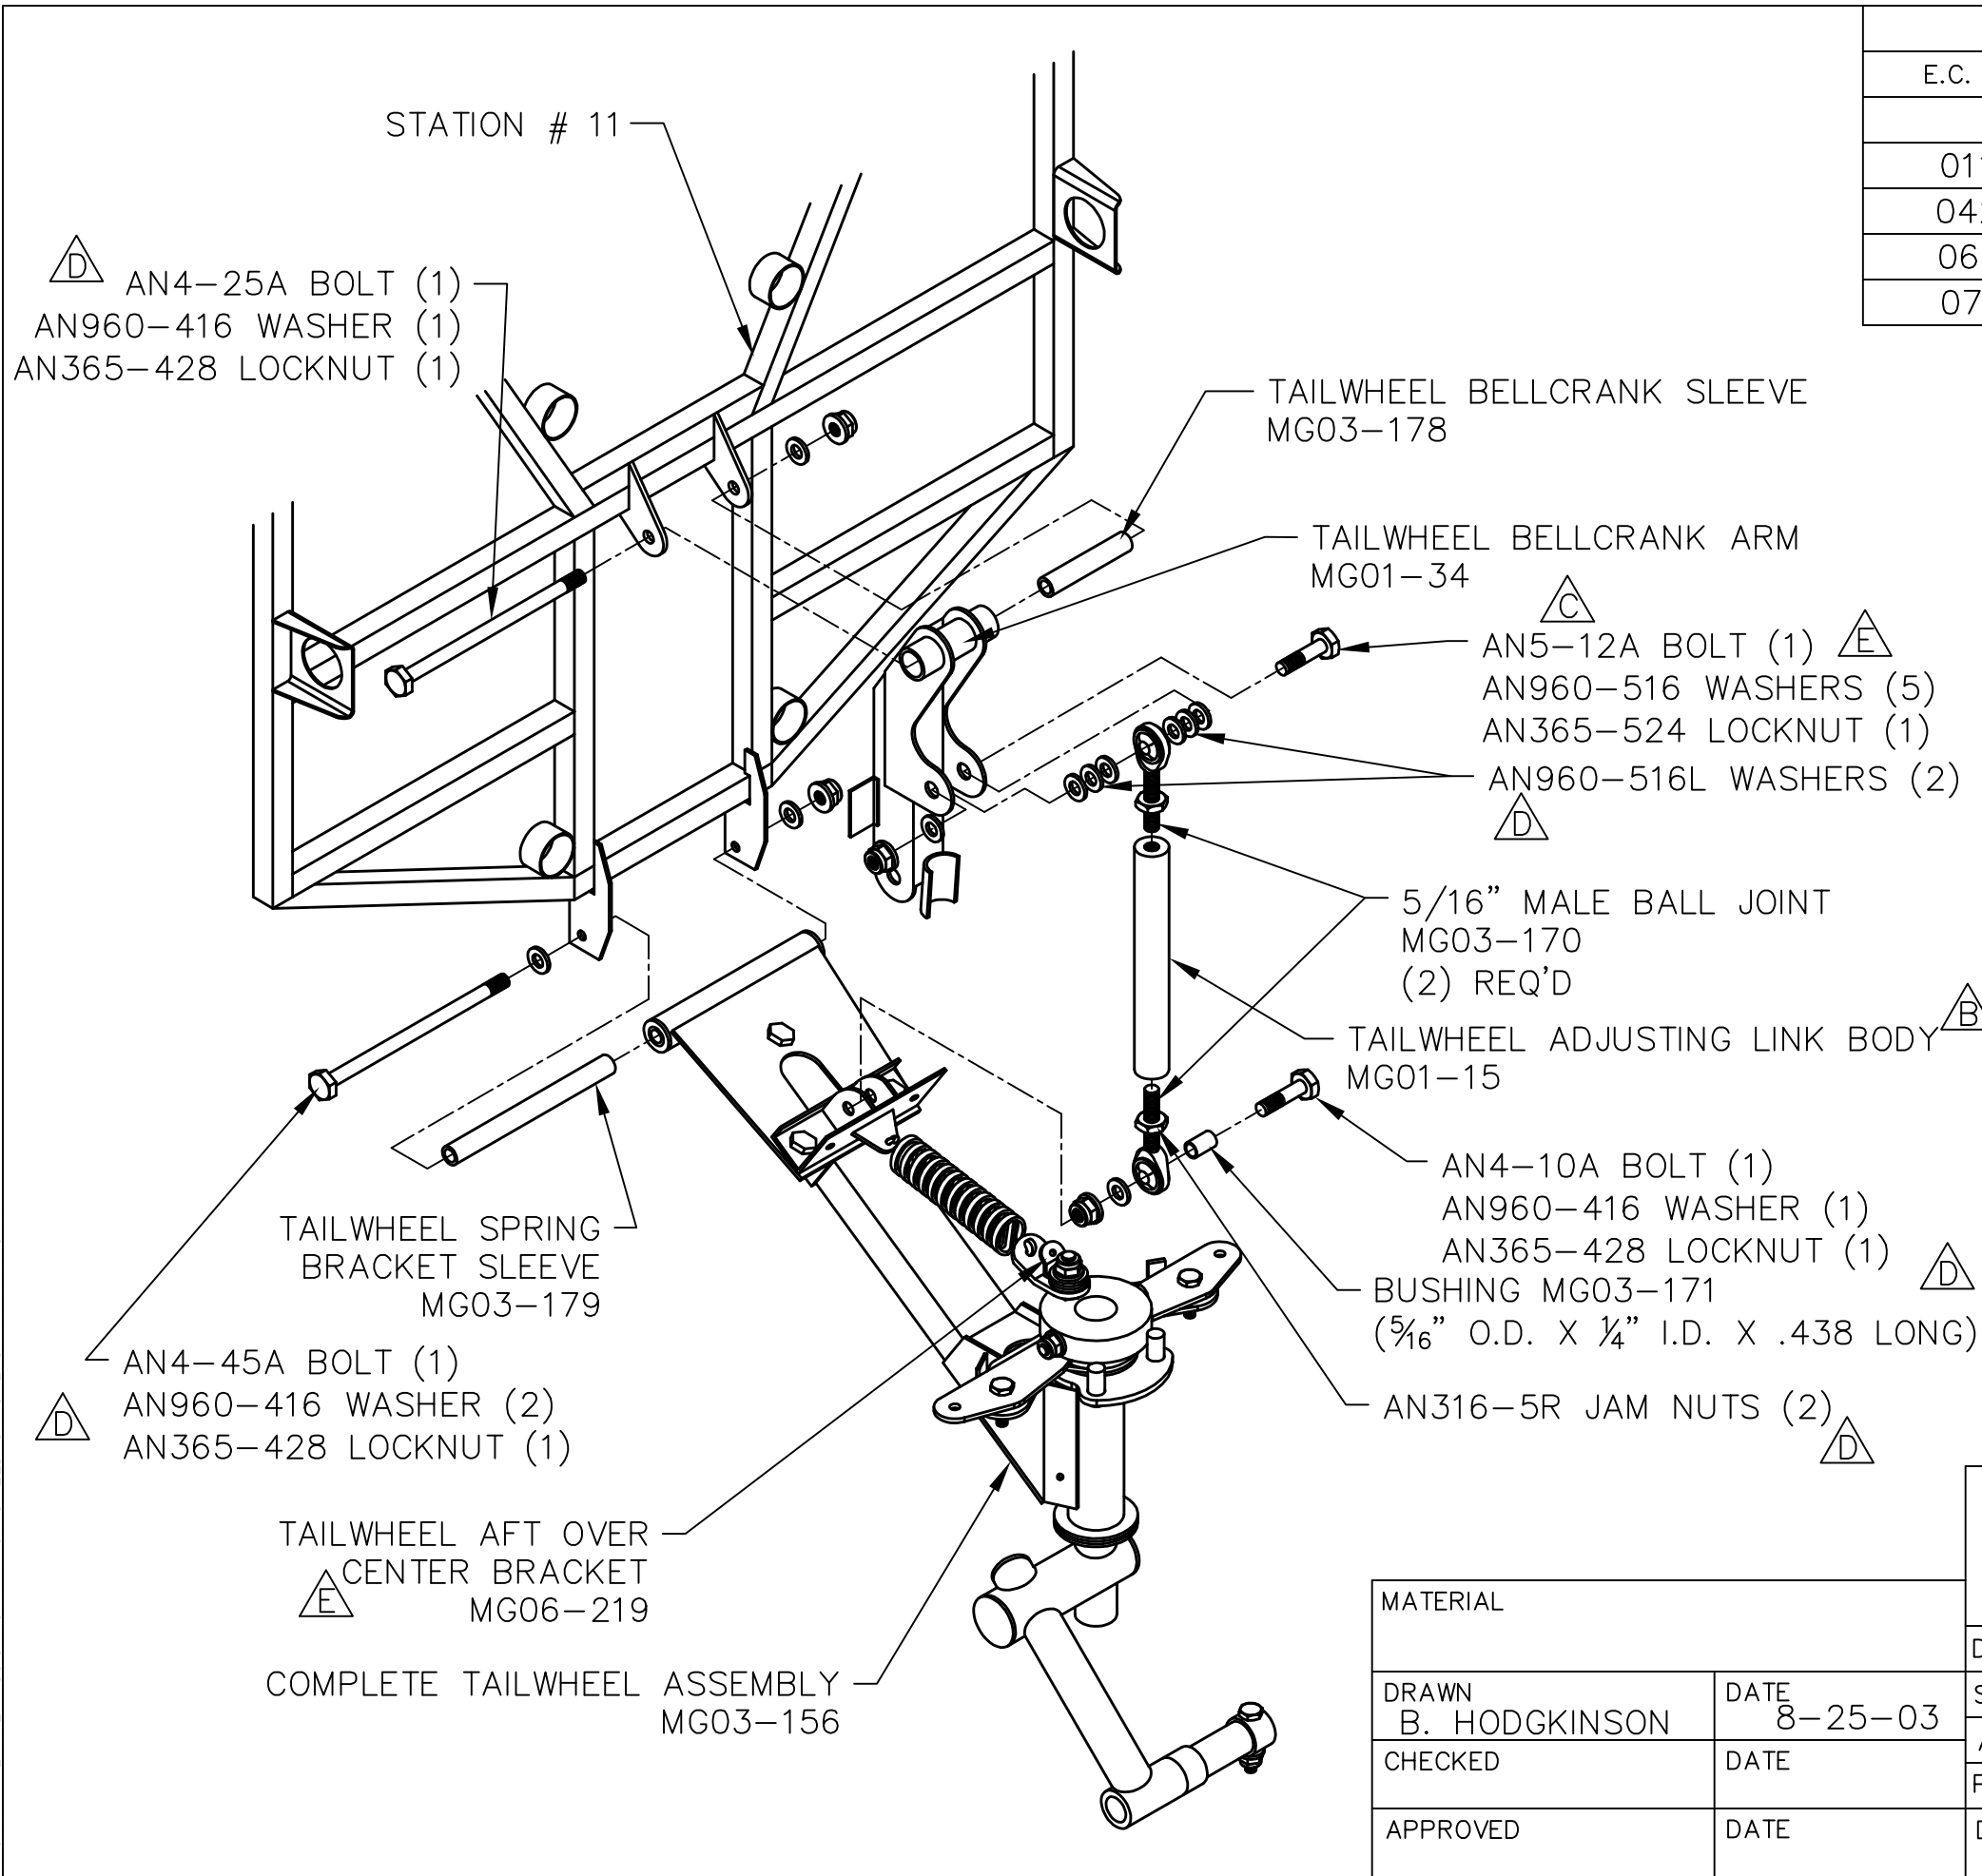
MATERIAL		DETAIL NAME AS NOTED	
DRAWN B. HODGKINSON	DATE 8-25-03	SCALE 1/4"=1"	PART NO. AS NOTED
CHECKED	DATE	ASSEMBLY NAME TAILWHEEL INSTALLATION INSTRUCTIONAL	
APPROVED	DATE	PART NO.	DRAWING NO.
		DRAWING NO. B T51-03-INS-0816-E

An aircraft, with approximately 150 hours of service on a rough grass field, was found to have the support tube at station #11 twisted. This caused the tailwheel to retract while the aircraft was landing, resulting in damage to the gear doors.

Using the aft baggage compartment opening, inspect station #11 to see if there is a second tube welded in place above the over center support bracket tube, as shown on the attached drawing number T51-03-INS-0816-E. If there a second tube no further action is required, if not, see below.
