## **Advisory Notice for Titan T-51 Mustang Aircraft**

August 17, 2010

### **Service required before any further flights**

DETAIL NAME ROTAX 912/914 THRUST PLATE INSTALLATION

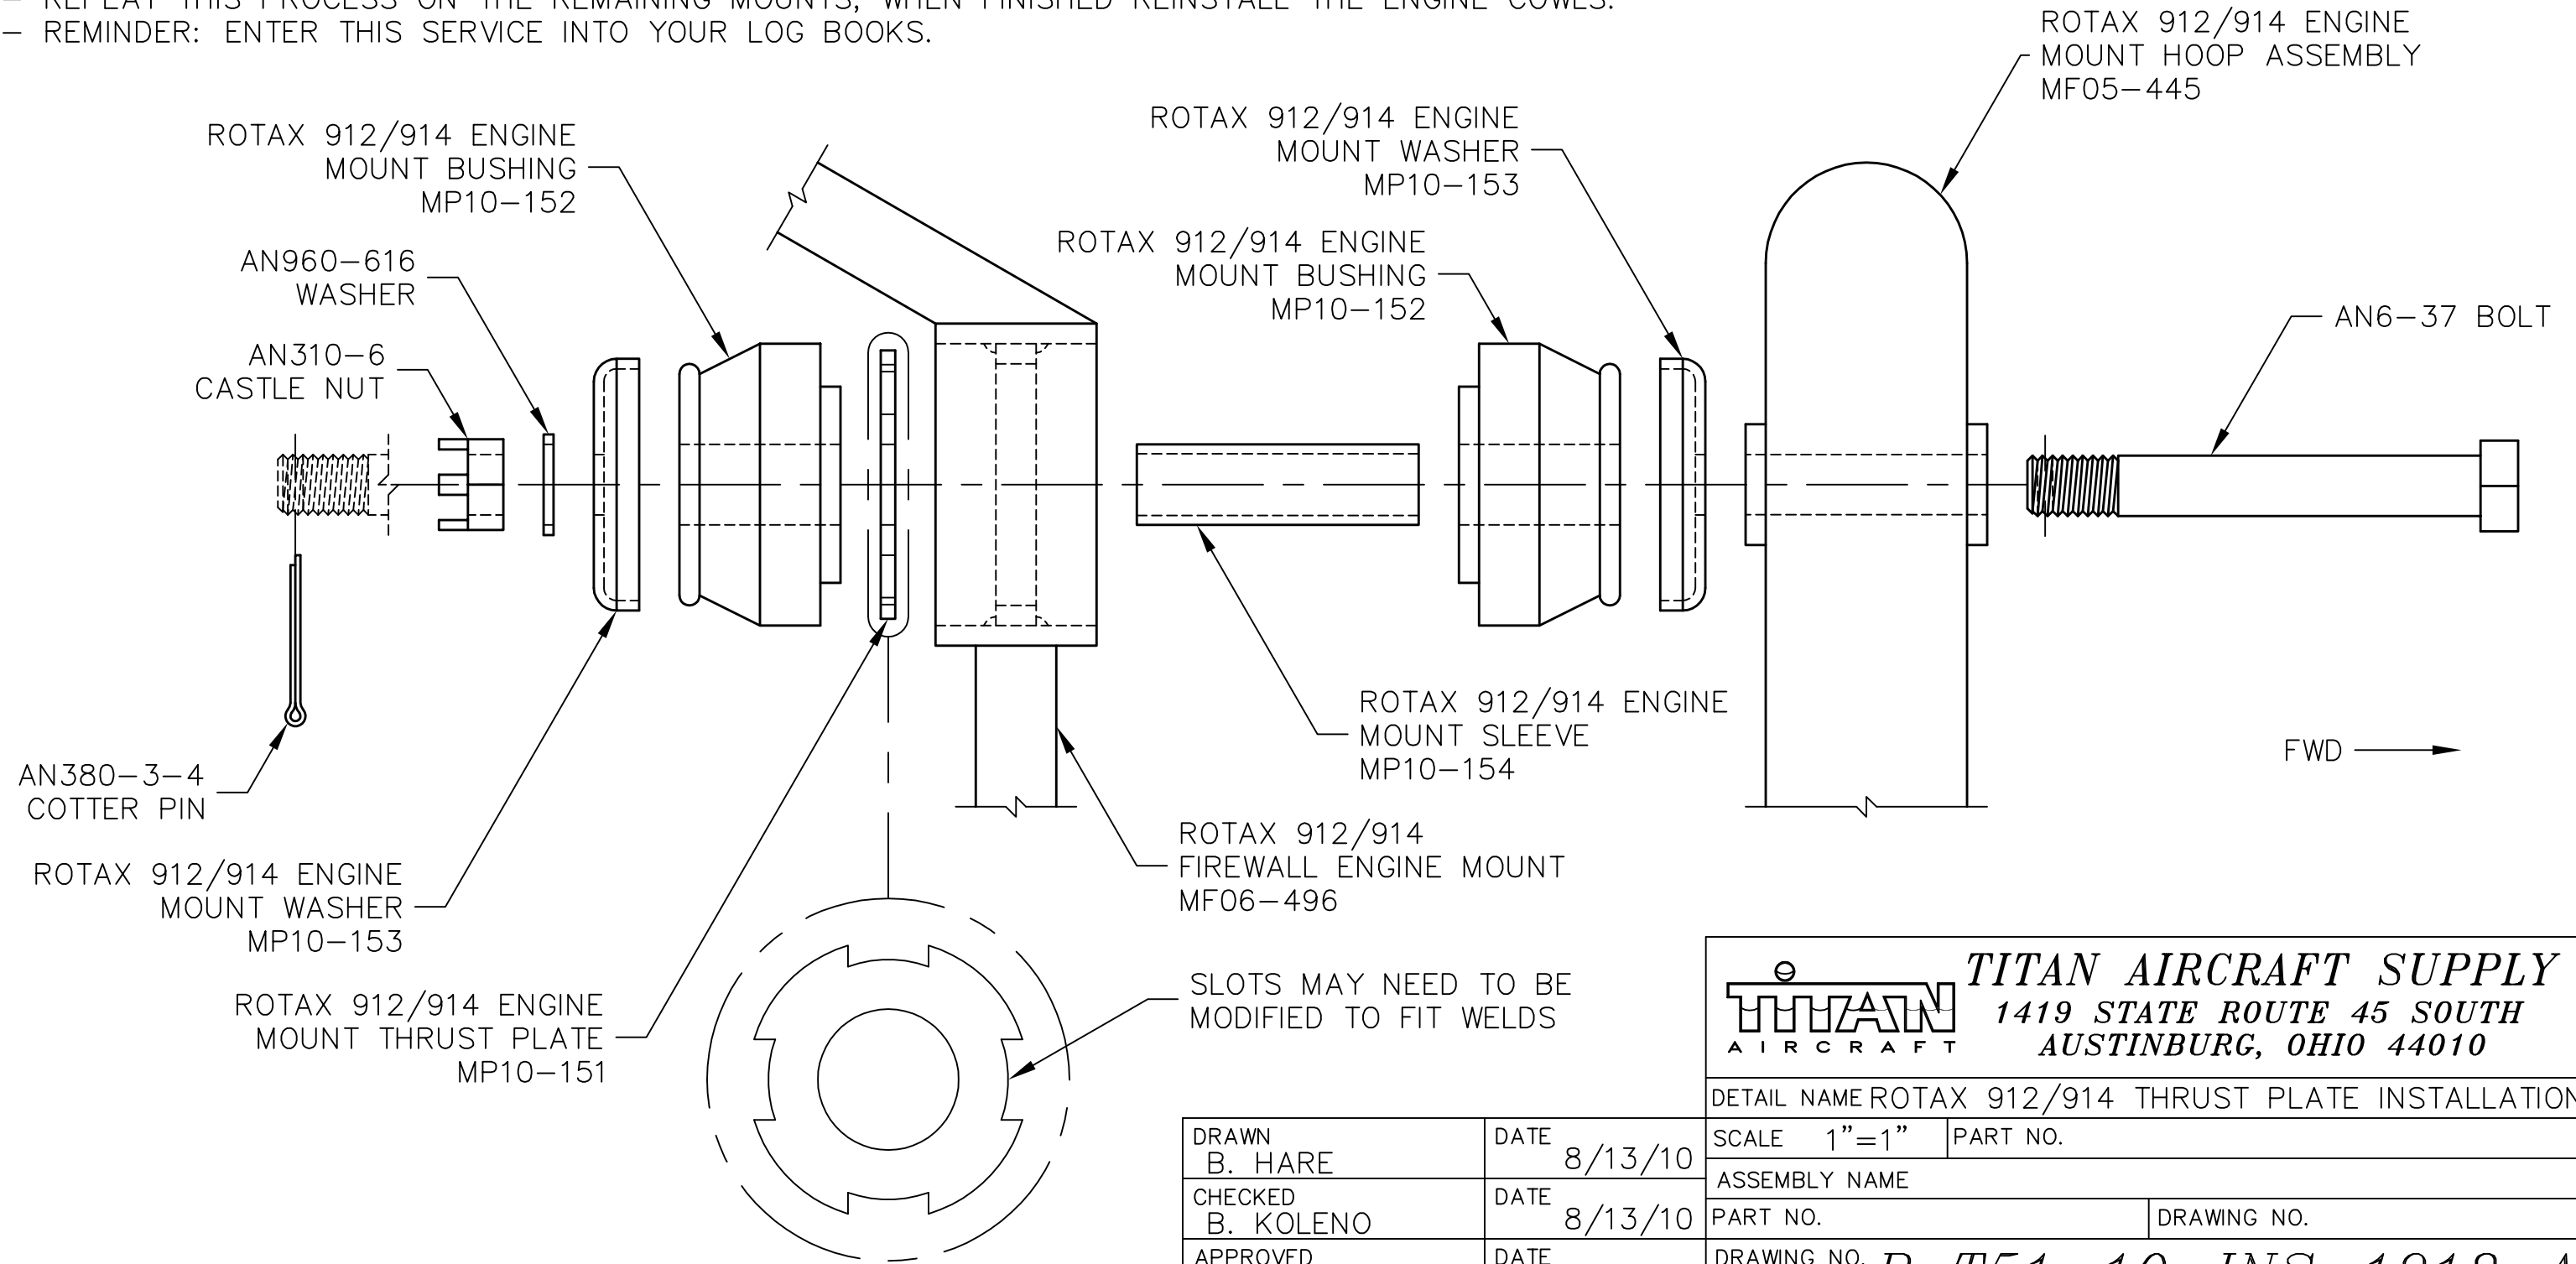
In a recent test of a Rotax 912 equipped T-51 Mustang, it was found that the upper aft engine mount bushings had deformed and started to pull through the bushing mount cups on the firewall engine mount. Upon teardown and inspection, it was determined that this was due to the amount of seat area available in the bushing mount cups. Along with this incident, there have been two other reports of 912 equipped T-51s with the same problem.

Follow the attached instructional to install the (4) Engine Mount Thrust Plates (MP10-151). These plates increase the seat area and will not allow the bushing to deform/pull through.

- REMOVE ENGINE COWLS FROM AIRCRAFT.
- WORK ON THE MOUNTS ONE AT A TIME.
- FIRST REMOVE AN380-3-4 COTTER PIN AND THEN THE AN310-6 CASTLE NUT, AN960-616 WASHER, ENGINE MOUNT WASHER (MP10-153), AND ENGINE MOUNT BUSHING (MP10-152).
- TEST FIT THE ENGINE MOUNT THRUST PLATE (MP10-151). YOU MAY HAVE TO MODIFY THE SLOTTED AREA TO MATCH THE WELDS IN THE FIREWALL ENGINE MOUNT CUPS.
- ONCE THE THRUST PLATE SITS FLAT IN THE CUP, REINSTALL THE ENGINE MOUNT BUSHING, ENGINE MOUNT WASHER, AN960-616 WASHER, AN310-6 CASTLE NUT, AND A NEW AN380-3-4 COTTER PIN.
- REPEAT THIS PROCESS ON THE REMAINING MOUNTS, WHEN FINISHED REINSTALL THE ENGINE COWLS.
- REMINDER: ENTER THIS SERVICE INTO YOUR LOG BOOKS.
