Advisory Notice for Titan T-51 Mustang Aircraft

March 4th, 2020

Inspection required before any further flights

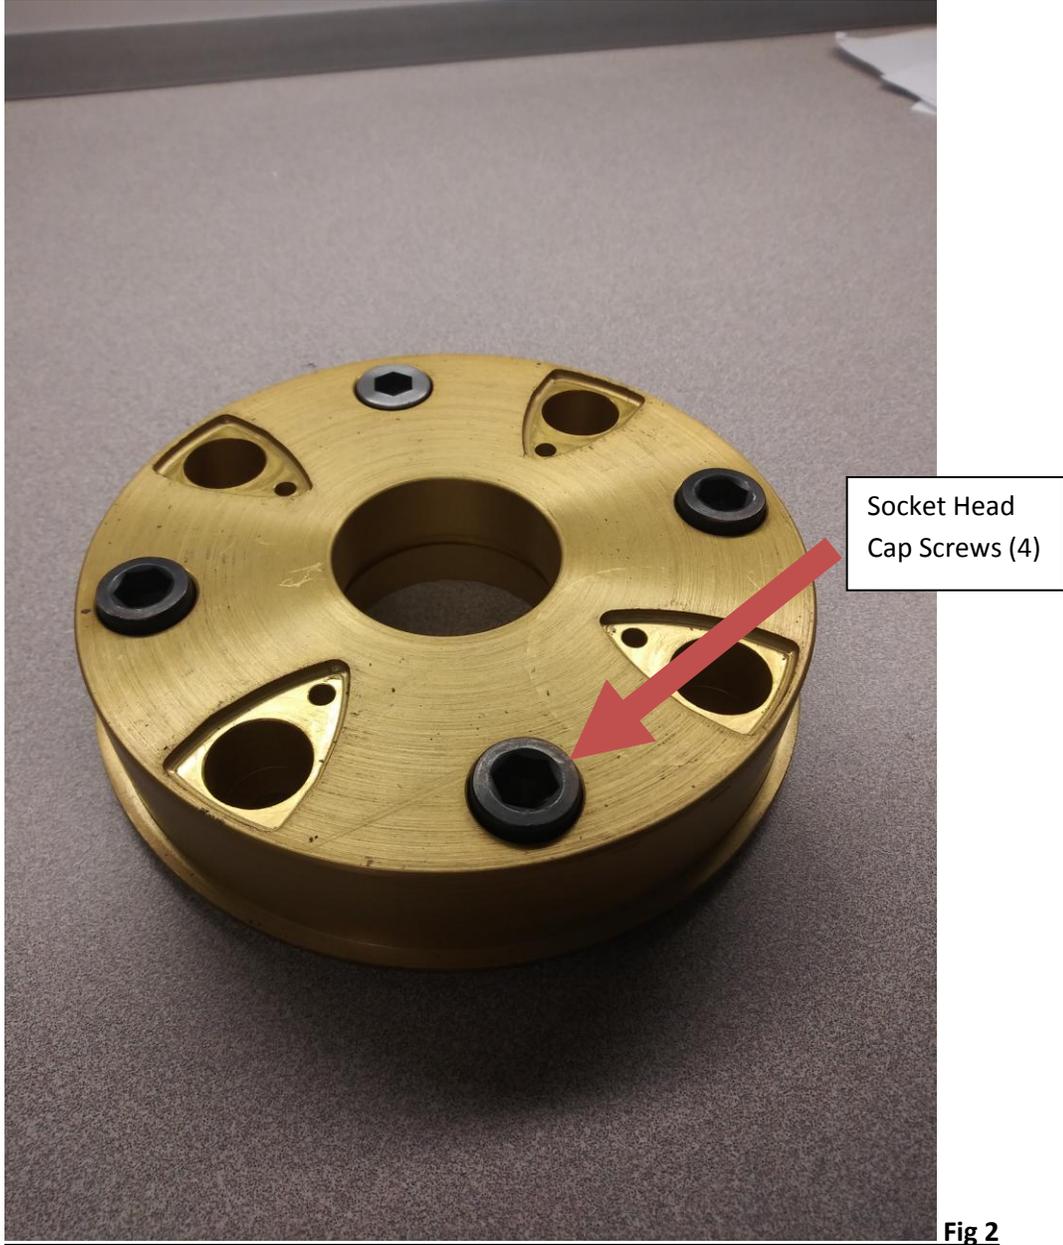
Fig 2

When the Elastomeric coupler is installed it may come in contact with the socket headed cap screws that secure the adaptor plate to the fly wheel (see fig 2) . This changes the installation height which in turn puts lateral pressure on the engine crank shaft which may result in excessive wear on the crank shaft thrust bearing. Which in extreme cases may result in engine damage.

Remove the gearbox from the aircraft and remove the Bolts in question. Then Machine 1/8" off the Cap screw bolt heads. Then reinstall the Bolts. This will provide adequate clearance between the bolt heads and the elastomeric coupler.

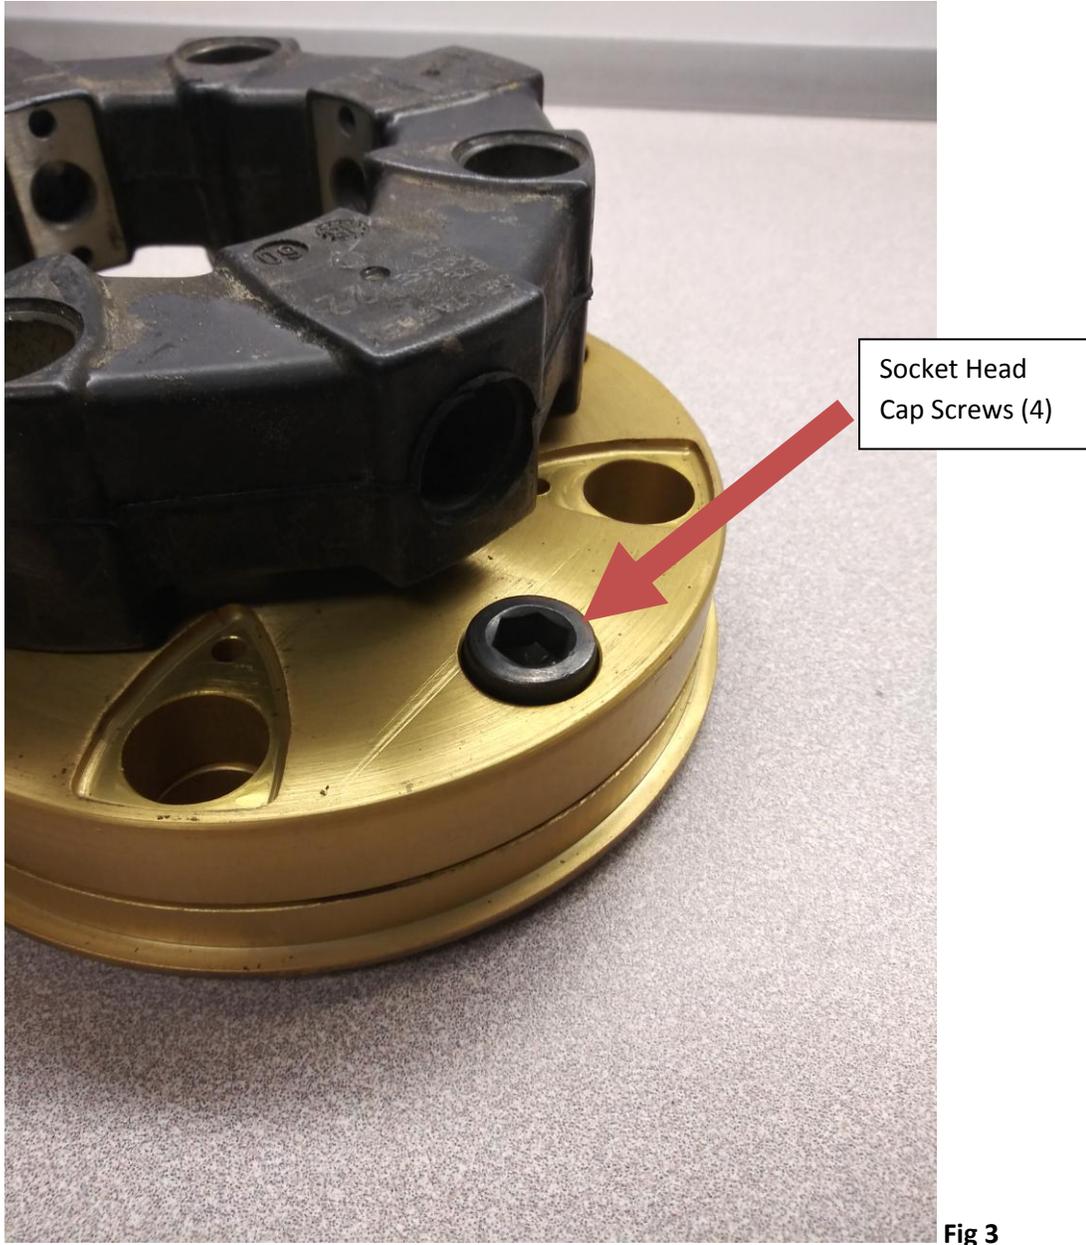
UNMODIFIED BOLT HEAD CLEARANCE

When the Elastomeric coupler is installed on the thrust bearing of the V8 crank shaft, it may come in contact with the socket headed cap screws that secure the adaptor plate to the fly wheel. This changes the installation height which in turn puts lateral pressure on the engine crank shaft which may result in excessive wear on the crank shaft thrust bearing. In extreme cases, this may result in engine damage.

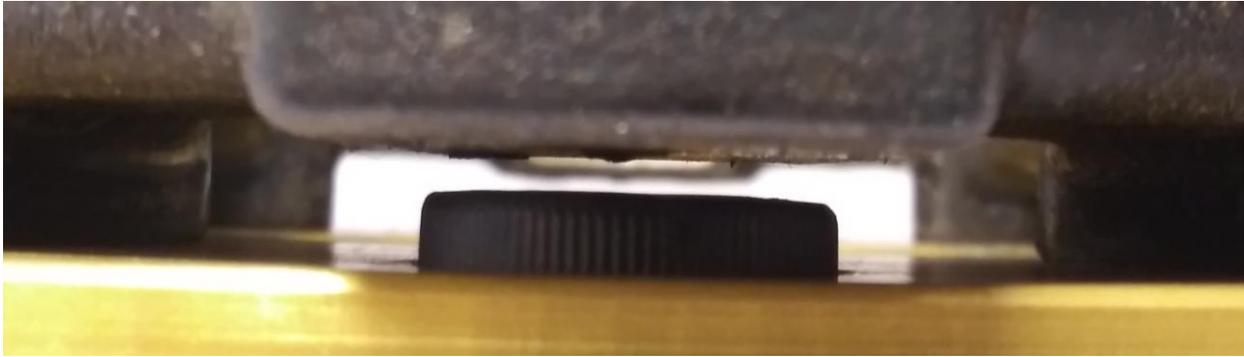
Fig 4

The 1/2-20 7/8 bolts in the **Drive Adaptor** contact the **Elastomeric Coupler** while in operation, and may potentially cause a failure in the engine by applying a lateral load against the thrust bearing. Machining the head of Socket Head Cap Screws so that you can fit a **0.020 Feeler Gauge** between the bolt and the **Elastomeric Coupler**. This may be as much as 0.125" This will make the bolt head flush against the **Drive Adaptor**. While assembled in the aircraft, check this measurement by rotating the engine until the bolt lines up in the gearbox window at the bottom . You may now check the clearance of each Socket Head Cap Screws. If the clearance is inadequate, then the gearbox must be removed from the aircraft the bolts in question will need to be removed and machined for adequate clearance. If you have questions on the removal process, contact sales@titanaircraft.com or call 440-275-3205.

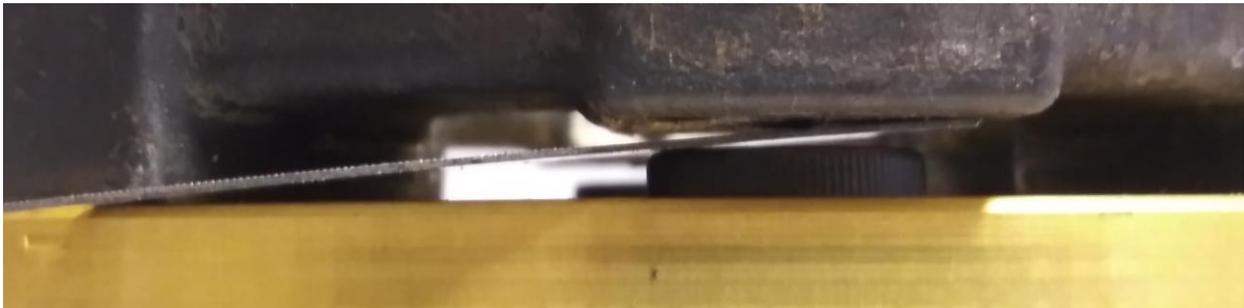
Fig 5

0.020 Feeler Gauge between bolt and Elastomeric Coupler.

If the part is assembled and your clearance resembles this, the part is ok.

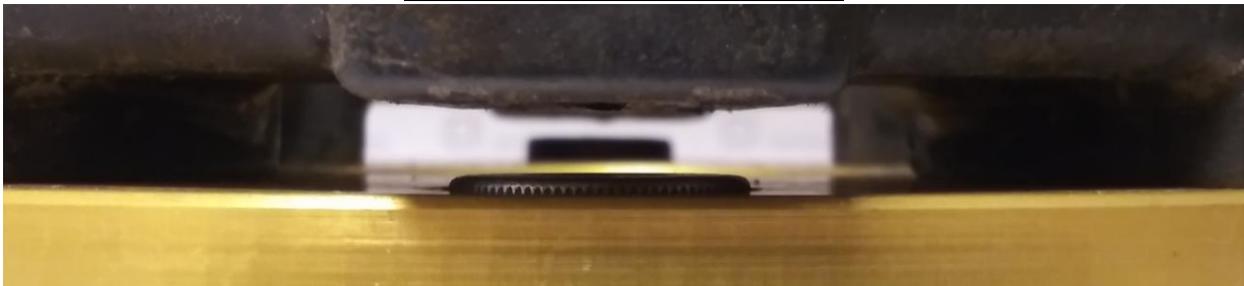
Fig 6

CORRECTED BOLT HEAD CLEARANCE

Proper Clearance should look like this.
